Walk Around

Messerschmitt Bf 109G

Walk Around Number 43

By Hans-Heiri Stapfer

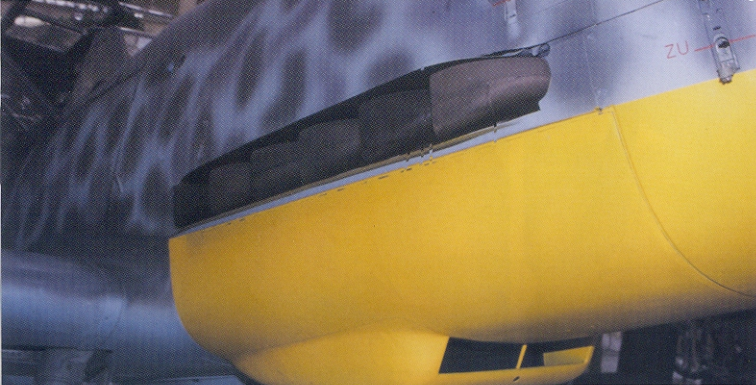
▼ The starboard engine cowling of a Bf 109G-4. The two small air intakes provided cooling air for the spark plugs and ejector exhausts. These intakes became necessary with the introduction of the more powerful Daimler Benz DB 605A engine of 1,475 hp. Similar intakes were located on the port side. The Bf 109G was the first variant to be equipped with the DB 605A. The previous Bf 109F-4 variant was equipped with a Daimler Benz DB 601E engine, rated at 1,350 hp at takeoff.

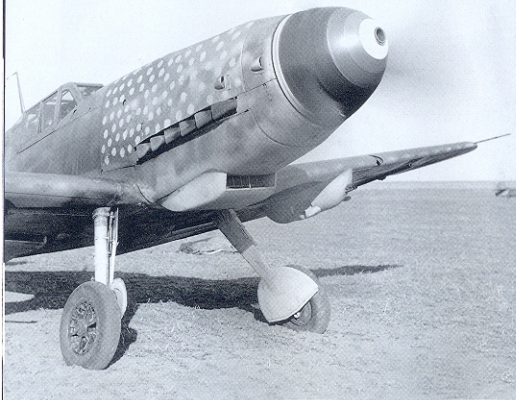
▲ The forward starboard air intake. A total of two such small intakes were attached to each side of the engine cowling. The intakes distinguish the Bf 109G from the earlier Bf 109F, which lacked these features.

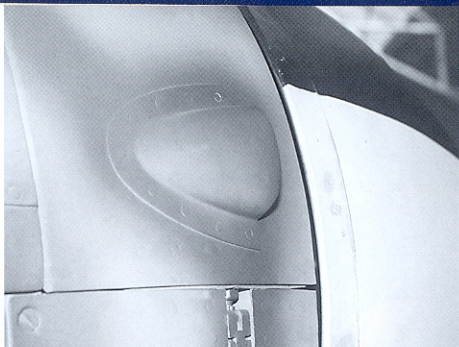
▼ The engine cowlings were secured by flush snap-fit fasteners, which allowed mechanics access to the engine without the help of tools. This enabled quick maintenance in the field and eliminated the danger of loose screws.

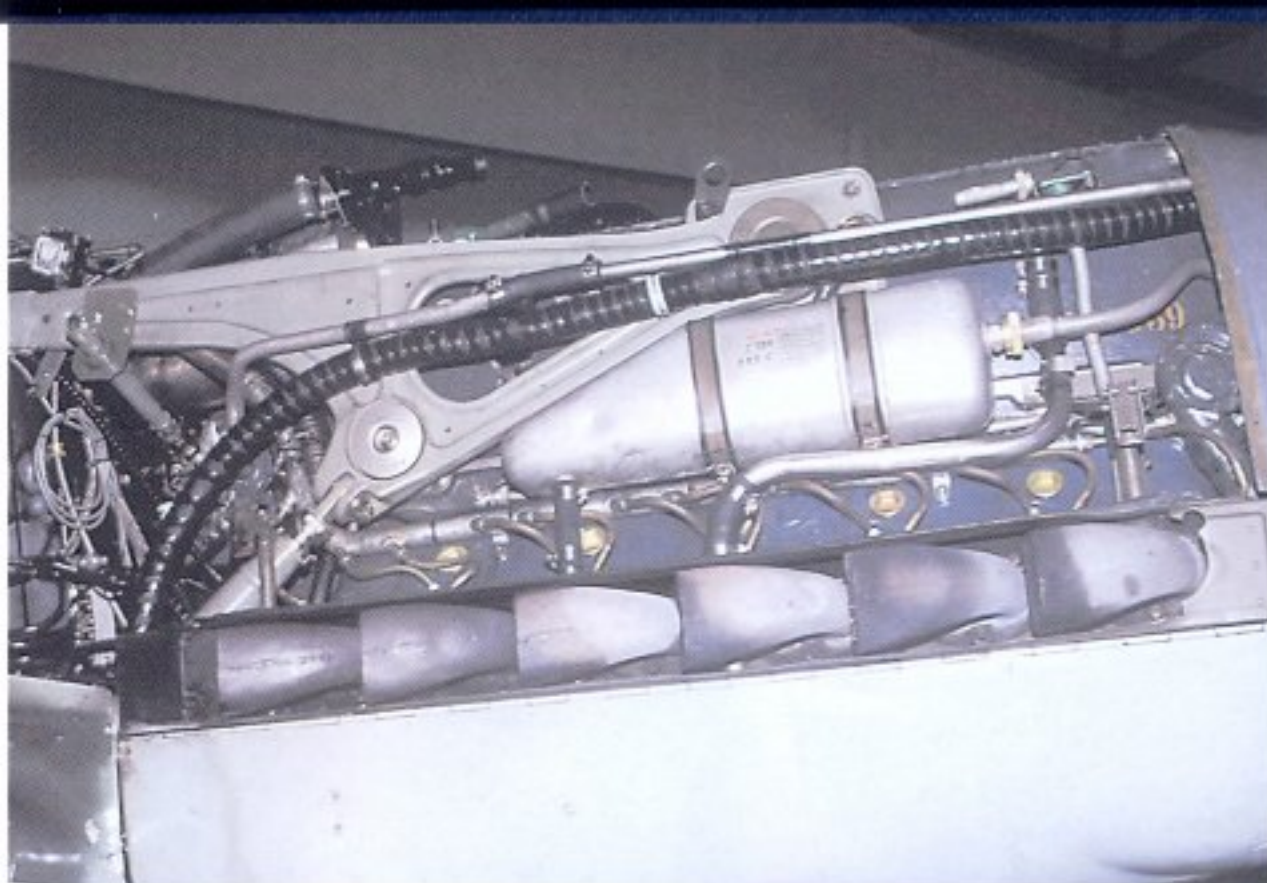
▲ The DB 605D engine of a Bf 109G-10. This engine was rated at 2,000 hp for takeoff, a remarkable 550 hp more than the DB 605A engine of the early Bf 109G variants. The Bf 109G-10 had electrical system distribution boxes mounted between the rear of the engine and the firewall. The early Bf 109G had two ammunition boxes in this location. The starboard engine mount remained nearly identical to that of the Bf 109G-6.

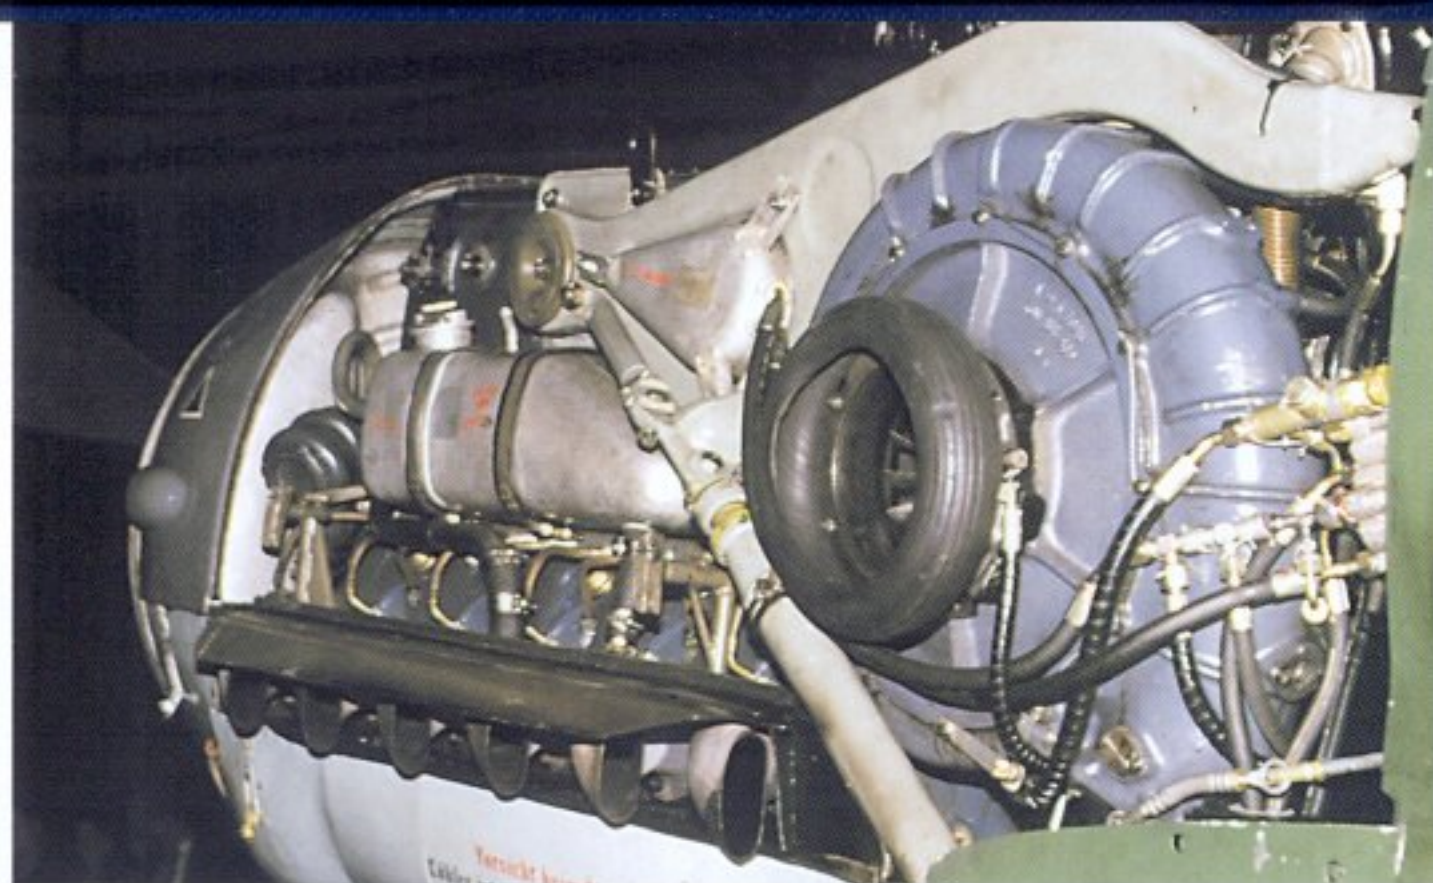
▲ Because it was larger than the DB 605A, the DB 605D engine of the Bf 109G-10 required a rearrangement of some of its accessory components. The supercharger of the DB 605D was larger in diameter and required a redesigned port engine mount. The heavier engine mount with its bends is a typical feature of the Bf 109G-10 and the subsequent Bf 109K-4. Earlier Bf 109G versions were not equipped with this type of engine mount.

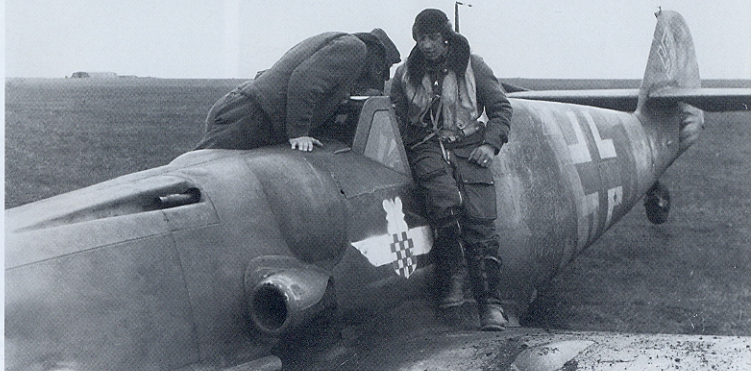
▼ The Bf 109G-5 was the first *Gustav* version to be equipped with the Rheinmetall-Borsig MG 131 13 mm machine gun, which replaced the Rheinmetall-Borsig MG 17 7.92 mm machine guns used by earlier *Gustavs*. The larger breechblocks and cocking mechanisms windshield. The larger breechblocks and cocking mechanisms of the MG 131 resulted in two *Beulen* on the upper cowlings just in front of the windscreen.

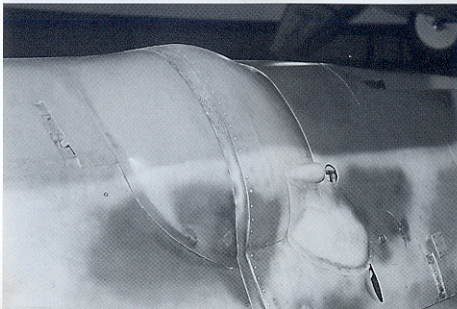
▼ The pressurized Bf 109G-5 had a unique *Beule* on the starboard engine cowl. On the lower part of the bulge was a blister, which covered the Knorr 300/10 air compressor. Attached to the *Beule* was a compressor intake scoop. As considerably more G-5 type engine cowlings were produced than actual Bf 109G-5s, a large number of Bf 109G-6s were equipped with the G-5 cowlings.

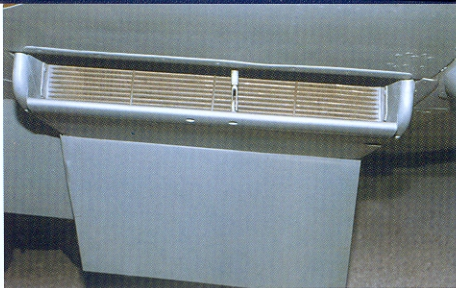
▲ An SKF/Behr ALF 750 B coolant radiator was mounted on the underside of each wings of the Bf 109G-4 aft of the main landing gear bays. Engine coolant passed through swirl chambers in the tank's air spaces, which released any vapor. Finally, the coolant moved through internal pipes to the tank outlets, where it passed to the radiator. The Bf 109G-1 to G-14 used the same type of wing coolant radiator, while the Bf 109G-10 was equipped with a larger ALF 907 C radiator. Control of the coolant radiator setting was done automatically.

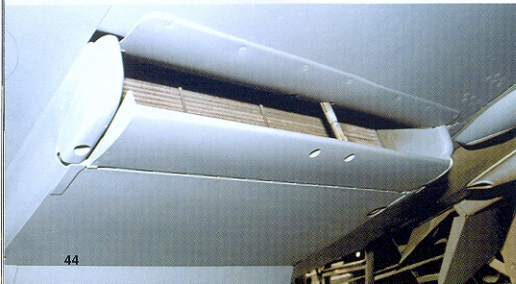
▼ The starboard SKF/Behr ALF 750 B coolant radiator. The Bf 109G cooling system used a mix of 50 percent ethylene glycol and 50 percent water during winter operations. This anti-freeze assured safe operations as low as -38° Celsius (-36° Fahrenheit), but this mixture often proved insufficient for *Luftwaffe* *Gustavs* operating in the severe winter conditions on the Eastern Front. Each radiator had a cooling surface area of 125 sq ft and a capacity of 1.1 gal.

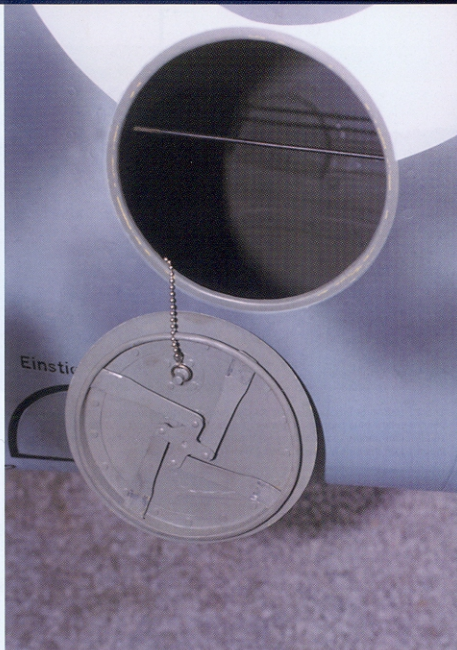
▲ A standard feature of Bf 109F and G variants was the circular access hatch for the master compass, located on the lower port rear fuselage above the footstep cover. A chain secured the hatch to the fuselage to prevent its loss. This access hatch was found only on the Bf 109F/G versions. The preceding Bf 109E lacked this access panel, as did the Bf 109K, the last main production variant of the Bf 109. Following World War II, the Soviets copied the design of this hatch and used it as the fuel filler cover for the MiG-15!

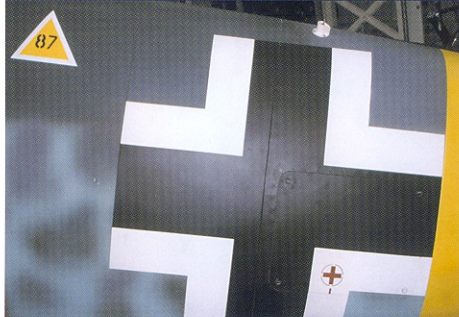
▲ The lead-in for the Lorenz FuG 16Z radio antenna and the access hatch for the radio and first-aid kit were located on the port rear fuselage. The position of the Red Cross logo on the access hatch varied from one manufacturer to the other, and some Bf 109Gs lacked the logo altogether. The lead-in location is inaccurate for this Bf 109G-4 (*Werknummer* 19310). The actual position was further aft.

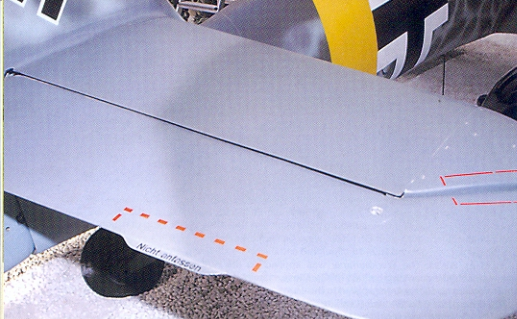
▲ The elevators of the Bf 109G-4 were fabric-covered metal structures, while the horizontal stabilizers (also called tailplanes) had metal skinning and structure. Both elevators moved in unison in a range of +33 degrees (up) to -34 degrees (down). The trim tab protrudes from the starboard elevator's trailing edge.

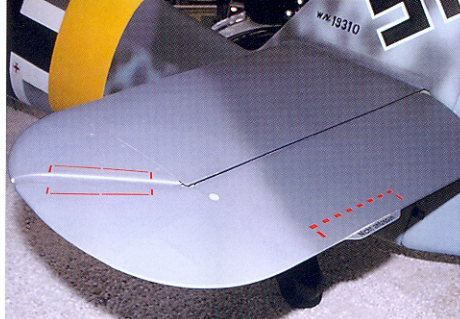
▼ A fixed, ground-adjustable trim tab was mounted on both port and starboard elevators. This tab held the elevator in the desired neutral position in flight. Some Bf 109G had a broken red line painted ahead of the trim tab, but this was not the case with all aircraft. The inscription "Nicht anfassen" means "Do not touch."

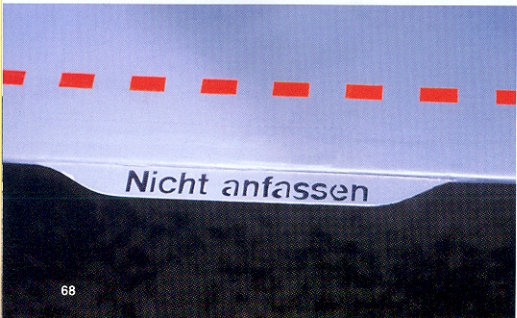
▲ The inboard end of the elevators were cut back at a sharp angle to allow full rudder movement. Maximum rudder movement was 34 degrees to both port and starboard. The red rectangles on the horizontal stabilizer and the elevator mark the location for control surface gust locks, applied when the aircraft was parked.
